## Dacia Jogger

Standard Safety Equipment

2021

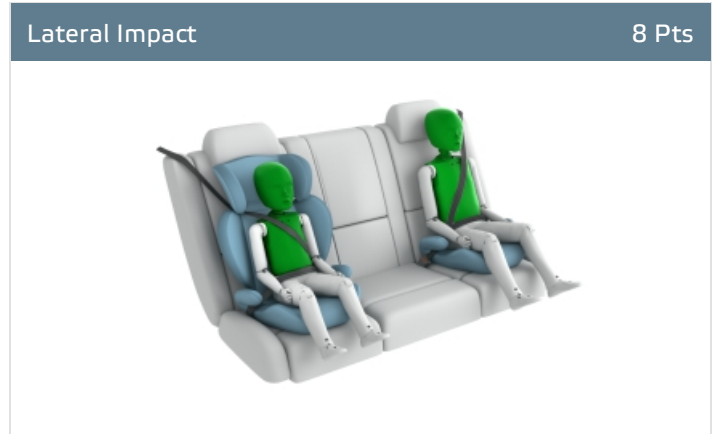
Crash Test Performance based on 6 & 10 year old children

Restraint for 6 year old child: *Britax Römer KidFix XP*  
 Restraint for 10 year old child: *Britax Römer KidFix XP (Booster only)*

In the frontal offset test, protection of the chest and neck of the 10 year dummy was rated as weak, based on dummy readings during the impact. For the 6 year dummy, protection of the neck was marginal while that of the head and chest was adequate and good respectively. The front passenger airbag can be disabled to allow a rearward-facing child restraint to be used in that seating position. Clear information is provided to the driver regarding the status of the airbag and the system was rewarded. One CRS, a full sized rearward facing toddler restraint, could be fitted in the car with no problem but was deemed a fail because Dacia indicate in the user manual that the car cannot accommodate this (R3) category of restraint. One type of universal restraint could not be properly fitted in the third row seats, where these are fitted. Otherwise, restraint systems could be installed and accommodated properly.

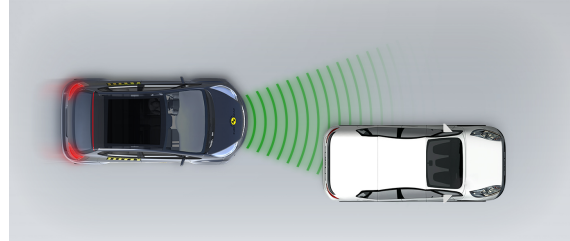
Approaching a stationary car
